CITY OF SAN ANTONIO
Department of Aviation
Aircraft Fire Rescue
Interdepartmental Correspondence Sheet

NATIONAL TRANSPORTATION SAFETY BOARD

STATEMENT OF WITNESS

DIAGRAM OF FLIGHT PATH

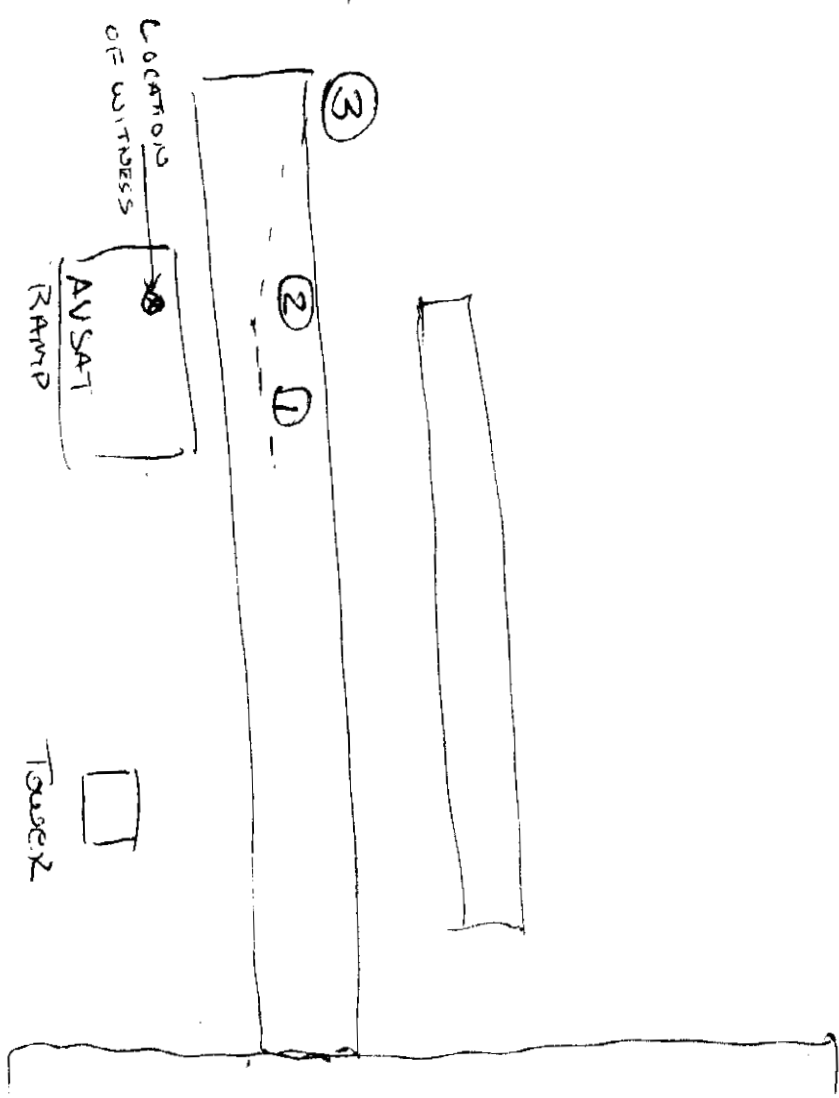
My family and I had just deplaned from our Cessna 421B on the AVSAT ramp adjacent to the departure end of the runway. My attention was called to the departing MU2 when I heard what sounded like compressor stalls. I turned to look at the runway and notice the MU2 accelerating down the runway. The aircraft rotated and lifted off just prior to being in front of me. Just as the aircraft was in front of me the following sequence of events occurred: 1. A loud cracking sound followed by an immediate prop wind down into feather. 2. The gear cycled up clean. 3. The aircraft assumed a climb attitude, accelerated and climbed away in a very shallow right turn. 4. The aircraft appeared to climb to 700 to 1000 feet AGL. 5. The aircraft attempted to initiate a slight left bank and appeared to develop a slow descent. 6. The aircraft initiated a pitch up in an apparent attempt to maintain altitude. 7. The aircraft continued to pitch up, the airspeed decayed as a result of the increased angle of attack and proceeded to execute a Vmc roll-over. 8. The aircraft entered a right hand spin with more than a 360deg turn in a nose low attitude prior to impact, it appeared as if the pilot may have stopped the spin, possibly by reducing power on the good engine but had insufficient altitude to pull out of the resulting dive.

It appeared as if the pilot on realizing that he was not 5 degs banked into the good engine had attempted to initiate a roll in that direction and the resulting spoiler deployment had negated his climb. Seeing a developing sink rate he made the mistake of trying to increase pitch to maintain altitude at the expense of maintaining Vyse. When he reached Vmc, he failed to maintain control of the aircraft by lowering the nose and reducing power on the good engine in an adequate time to prevent the roll over and resulting spin.
